RECREATING HISTORY

General Patton's Dodge Command Car

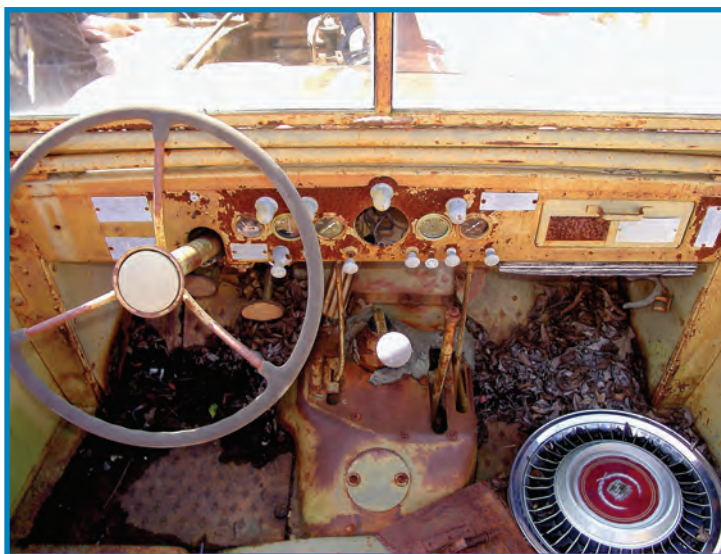
Top. The original dash on the Dodge WC57, as found, sitting outside where weather had taken a toll. Standing water and leaves had collected on the floorboards. We were lucky that rust was minimal.

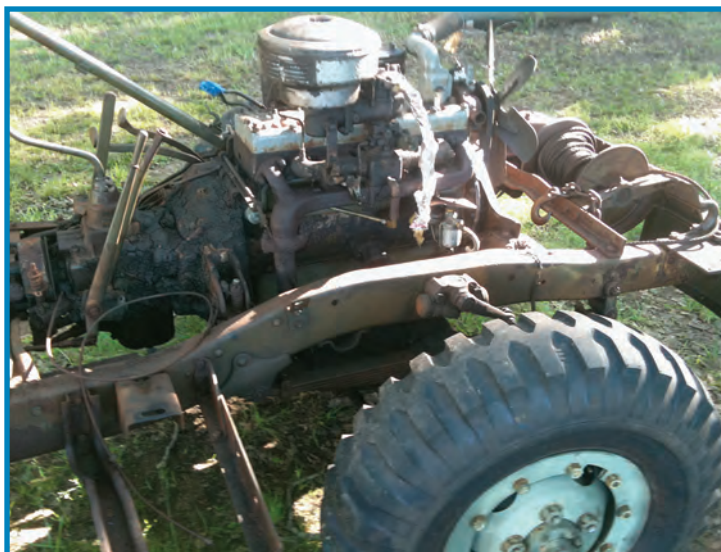
Middle. The engine before rebuild. To determine where we were at with the restoration we power washed the engine and frame. It had years of grease, dirt and crude covering it.

All the larger and heavy parts were blasted and primed. The engine was taken to a professional rebuild shop in Richmond, Texas where it received a complete overhaul. Simultaneously the larger parts were sandblasted, as well as the frame, and primed elsewhere. The generator and regulator were completely rebuilt. Carlos Manning, who is no stranger to MVs, was the overall project manager. He is the Chief of Staff for the Patton Third Army Living Historians, and is our grandfather figure, has helped so many people it would take too long to list them all. We love him and are grateful for all of his help.

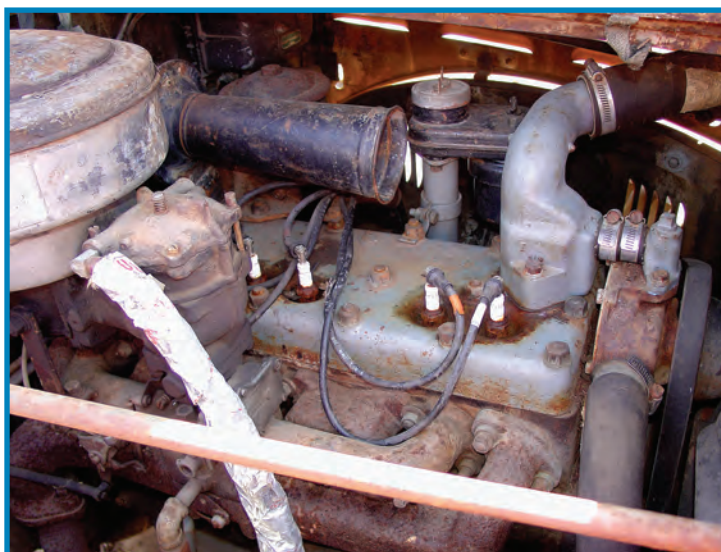
Bottom. Right engine side. The engine and compartment looked to be basically all there with no major modifications. We did not know whether it would run.

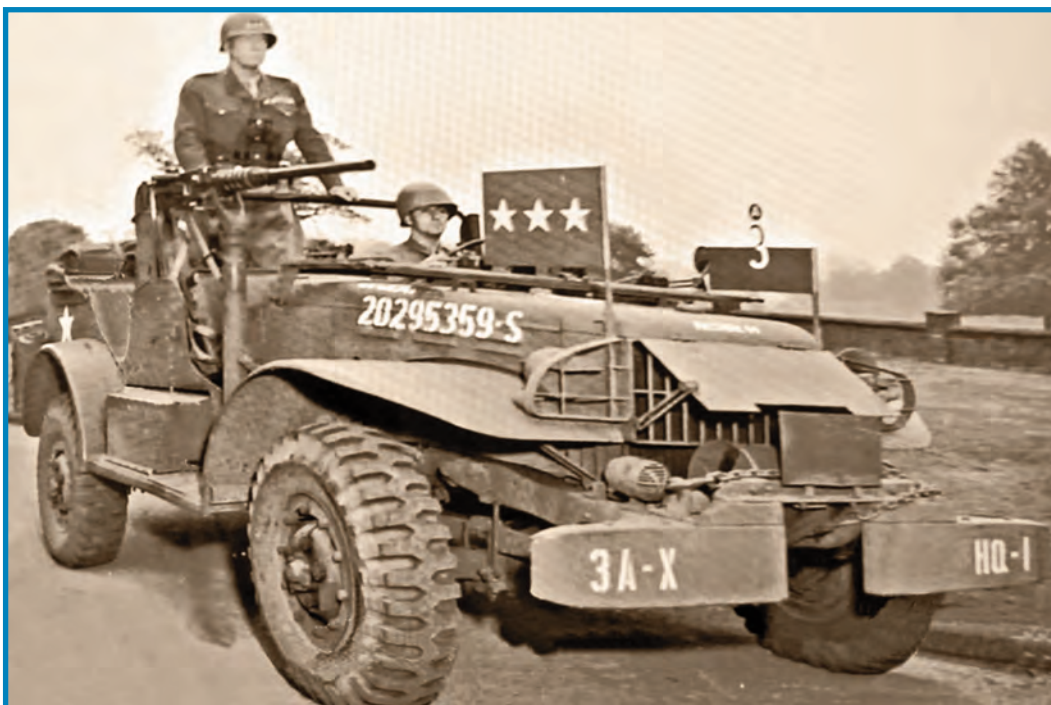
This is by far the rarest photograph known of General Patton in his command car. It was taken in England, at Peover Hall, Nutsford, Cheshire, along the side of the road leading to the mansion that had General Patton Headquarters in the Spring of 1944. The photograph was top secret as Patton's Third army was a secret and the vehicle was clearly marked. It was released by General Patton to

his men after the war as a sovenier. The Driver is MSgt. John L. Mims who drove Patton all through the war.

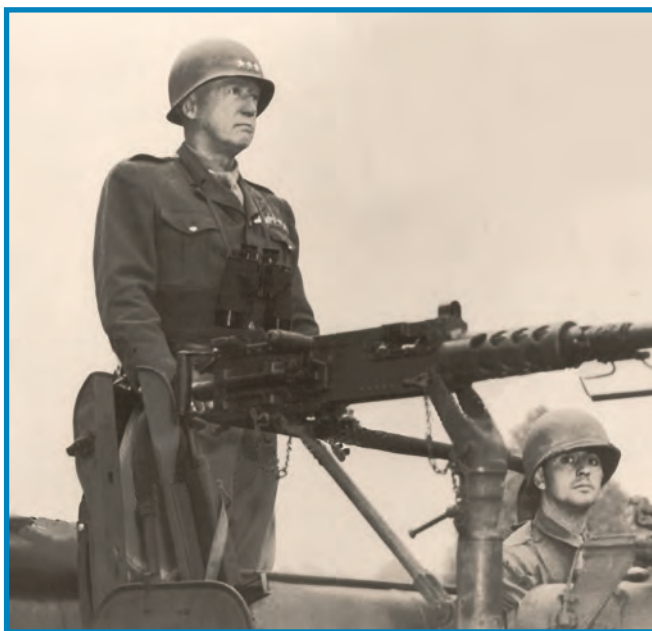
This picture was taken on the same day and time in England as the larger one. This was one of Patton's favorites and he often autographed them on request from friends.

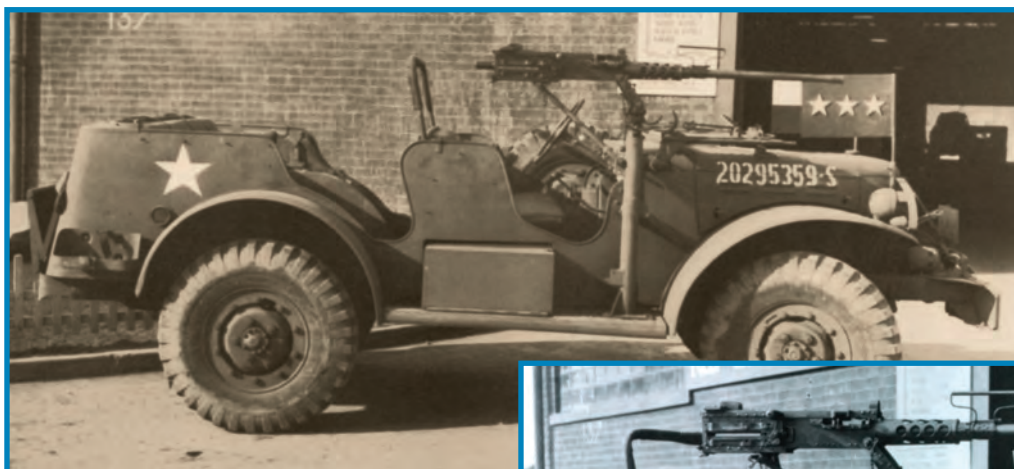
National Archives images of Patton's WC57 during modification. England, US Army Ordnance Depot, spring 1944.

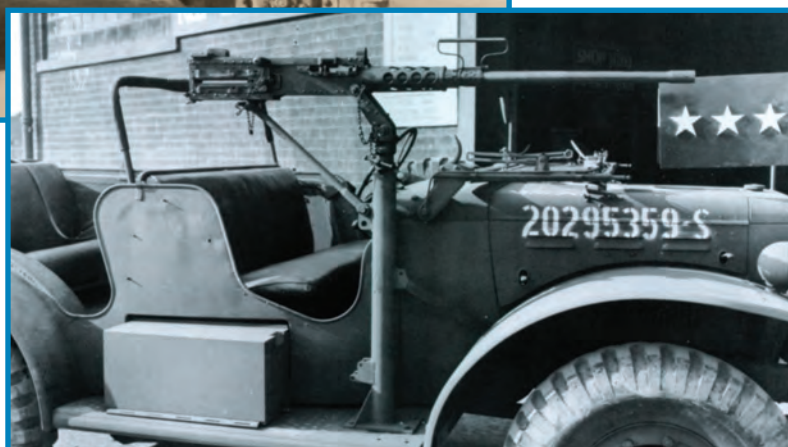
General Patton was fond of the .50 cal. M2 heavy barrel machinegun. He had one mounted on the side of his Command Car. It took a considerable effort by the US Army Ordnance depot to mount it so it would function and not vibrate itself lose when firing.

problem was mounting of the .50 cal. M2 post on the passenger side. A .50 cal. has a lot of weight and to mount one that could be fired without the mount coming loose took a lot a thought. The inside panels were reinforced near the passenger side and the bolting system was modified near the driver's side entrance.

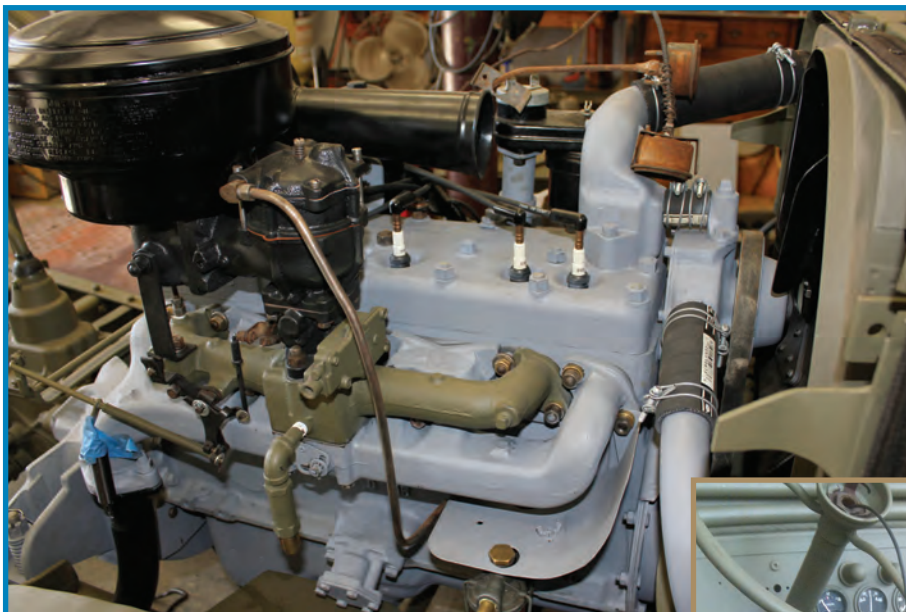
Front right engine. The engine compartment was assembled then the engine was then fired up and fine-tuned before the body was reassembled.

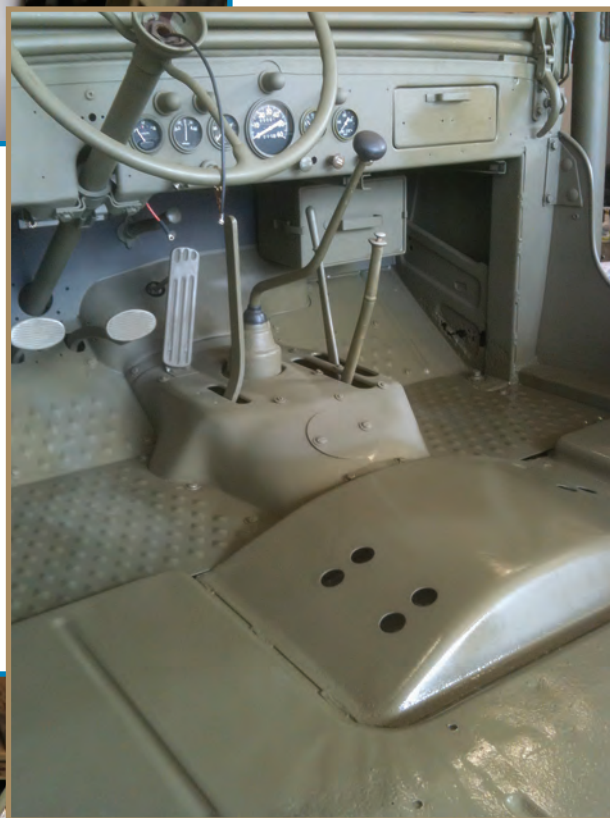
The floorboard, forward of the rear seat were serviceable and after sandblasting it came out well.

Rebuilding the WC57 Dodge command car, approximating General Patton's, was challenging on several levels. Steve labored hours over the replacement of a few key pieces of the rear of the floor and cut and rewelded the rear portion of the floor that had been damaged by rust. The reproduction parts used on this restoration were all purchased from Mid West Military. Some years before the command car had been hit hard from the rear and it took quite a bit of work to straighten it. This took many hours and was very time-consuming. It paid off as there are no dings and all the metal is now straight.

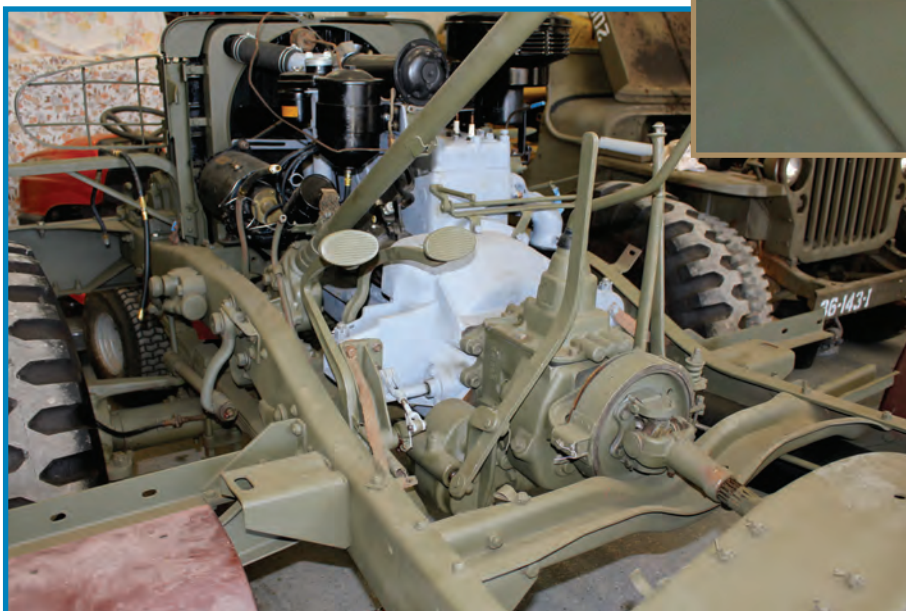
Rear view of engine. Once the engine and chassis was rebuilt and assembled, we matched the existing paint scheme from samples taken before the restoration.

Steve then took over the restoration from that point. The frame was painted, the brakes completely overhauled and synthetic DOT 5 silicone brake fluid was used. It does not absorb moisture and is worth the extra cost. Steve painted and mounted the engine. Strict attention was paid to color codes and the frame-up restoration came together.

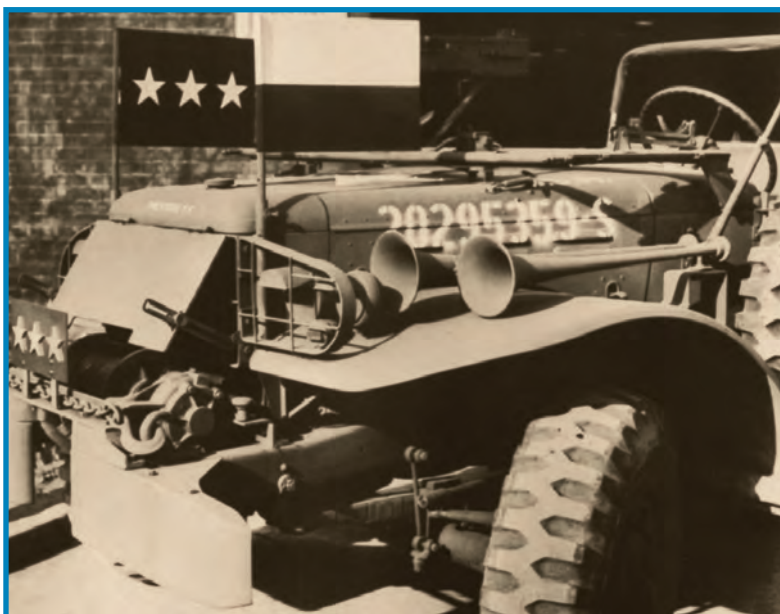
Original front view taken in England after modification with air horns. The 3rd Army flag was not painted, as Patton's command of Third Army was still a top secret due to Operation Fortitude and Patton heading a fake army intended to invade Calais, France.

Air horns were almost never used on WWII vehicles, unless your name was George Patton – he loved them and had them on all his vehicles. A set of the correct size air horns were found at *Air Horns of Texas* and then the really hard part came. Steve had to figure out a way to make them work and do what has not been done to a command car since WWII. He figured it out and... well; we'll keep that a secret for now. Suffice to say, they work and are very loud; Patton would have loved them. The next big

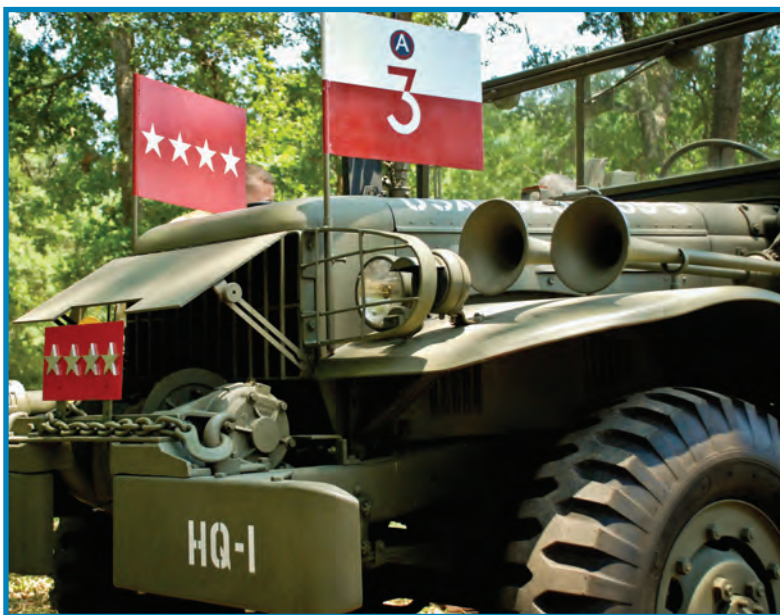
General Patton's rank and army flags were painted on all his command vehicles. We found one photograph of the four star rank which we used to honor him.

The final steps included fabricating the general's four-star rank plates. John Bizal came through with them. We were finally ready for the stencils. A call to Rick Larsen Military Stencils was made. He was sent photographs of the original command car markings and we got back excellent stencils. Though General George Patton spent most of the war as a lieutenant general (three star), towards the end of the war he was promoted to full general and we included the fourth star in honor of the last rank he held.

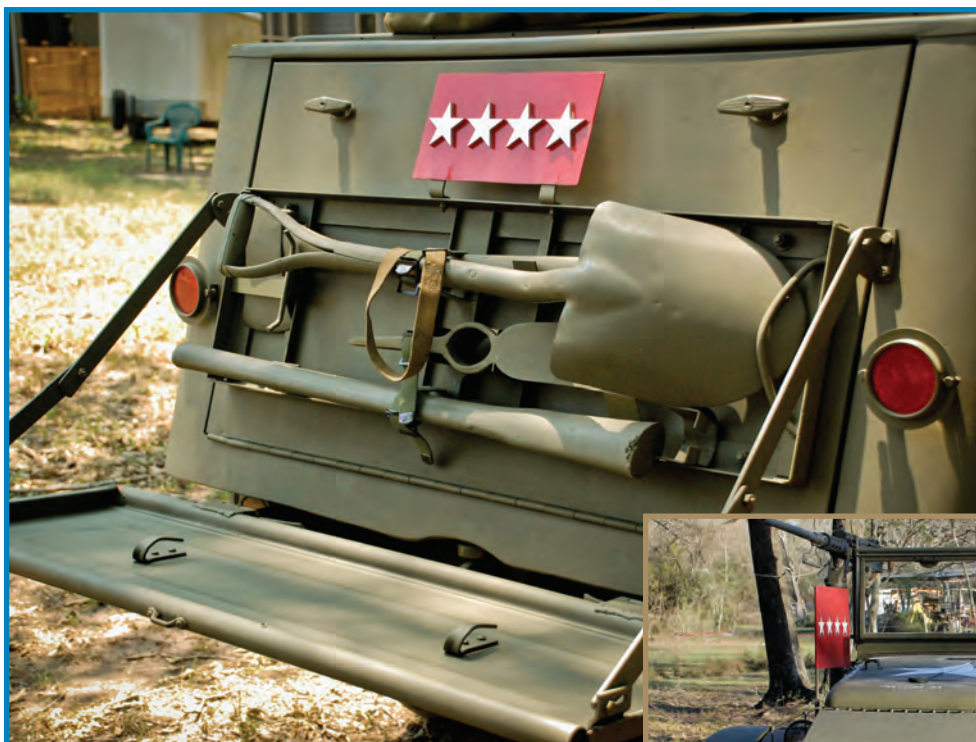
US Army Ordnance added the rear tailgate in 1944. They used a 3/4-ton Weapons Carrier tailgate. So did likewise.

The last major modification came at the rear of the command car. The US Army Ordnance Corps unit in England attached a Dodge weapons carrier tailgate to the rear of the command car. Installing it in the right place was difficult since all Steve had to go on was a photograph provided by Denny. There were no plans but a lot of study produced great results.

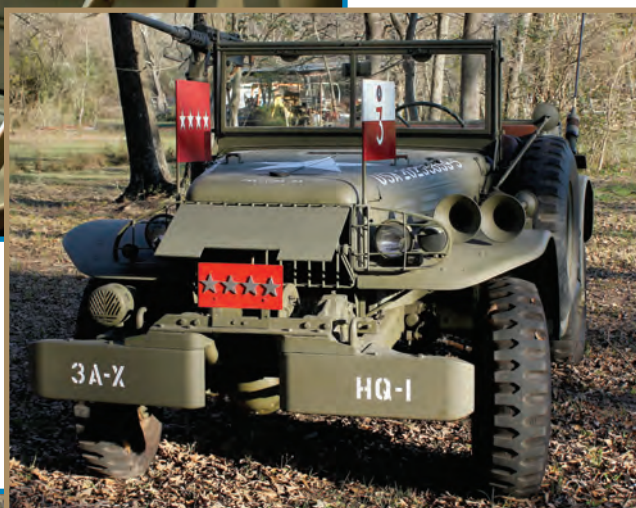
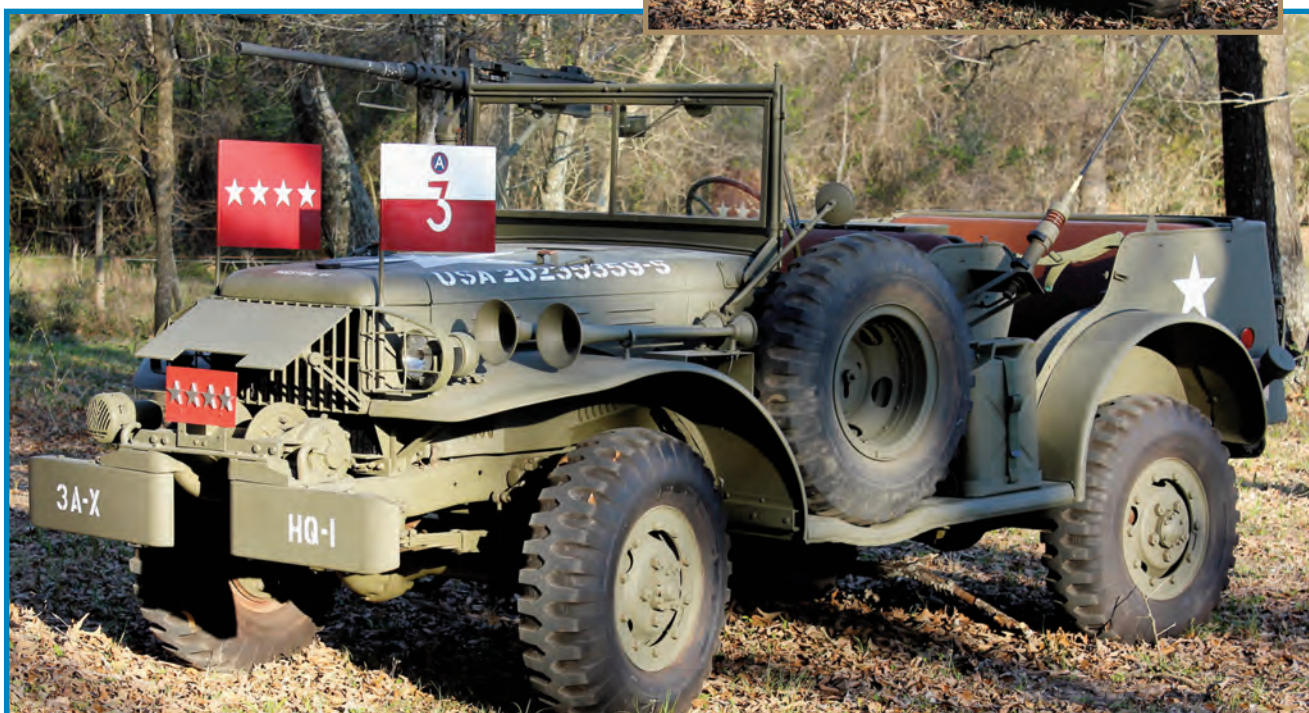
The vehicle markings were exactly replicated from actual photographs of the original Command Car.

The WC57 modified reproduction Command Car of General Patton's as it appeared in July 1945.
